BP Australia Installs & Commissions Pall GSS 3rd Stage Blowback Filter System to Reduce RCCU Flue Gas Emissions

BY MICHAEL GLENNY (BP KWINANA), THIERRY DARDE (PALL CORP) & LINDSAY MCRAE (PALL CORP)

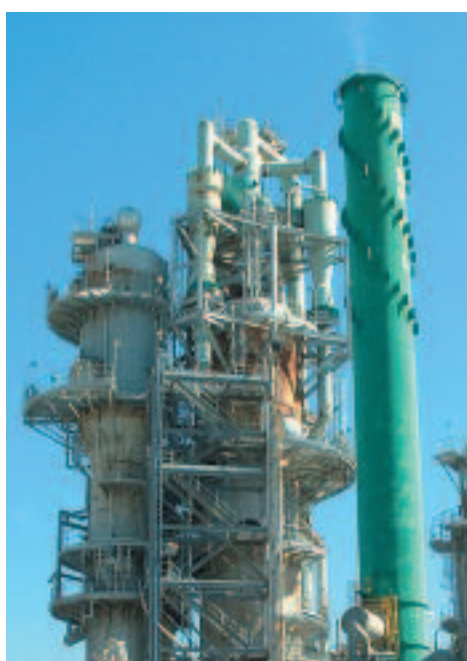
Fig 1: external cyclones BP Kwinana RCCU R2 regenerator

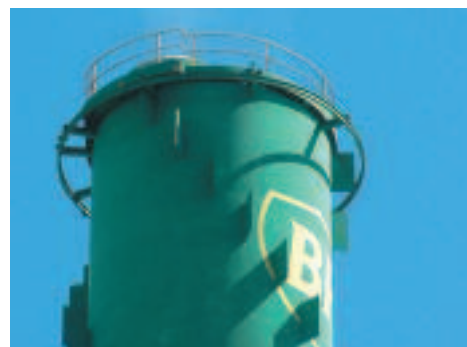
Fig 2: R1 & R2 common stack

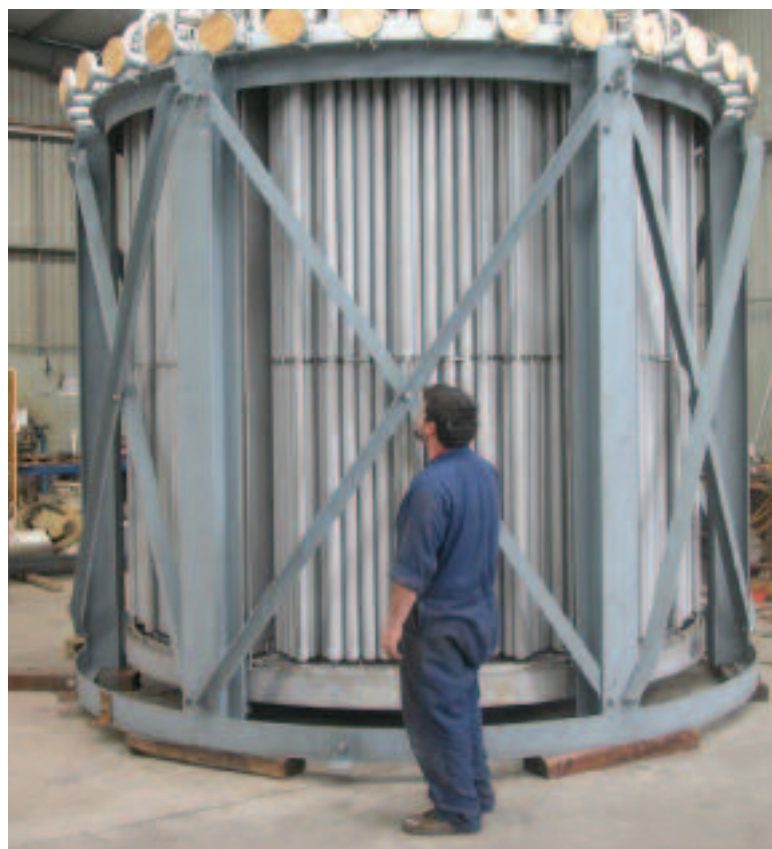
Fig 3: Tubeshheet assembly ready for shipment

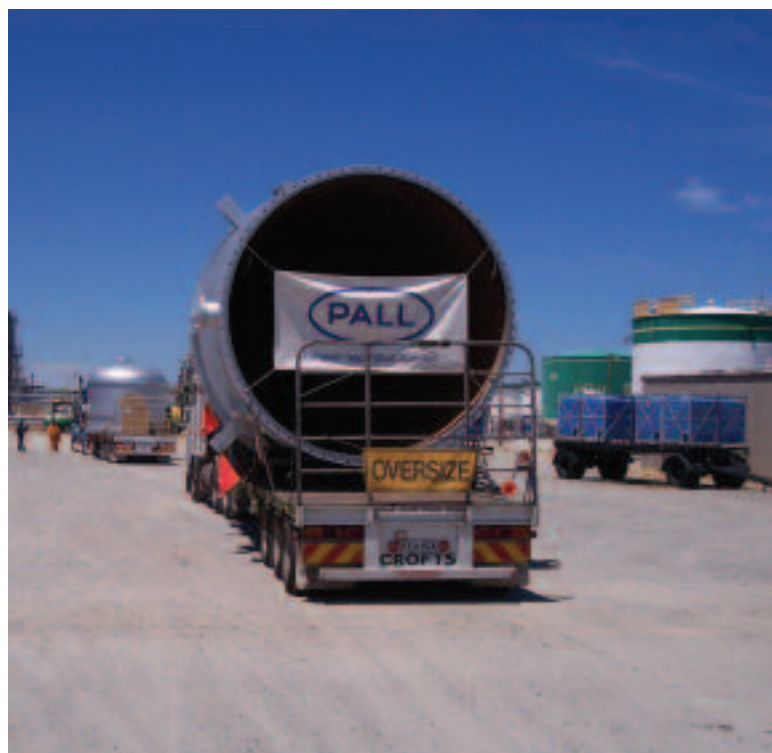
Fig 4: Filter vessels arrive on site at BP Kwinana, Perth, Western Australia

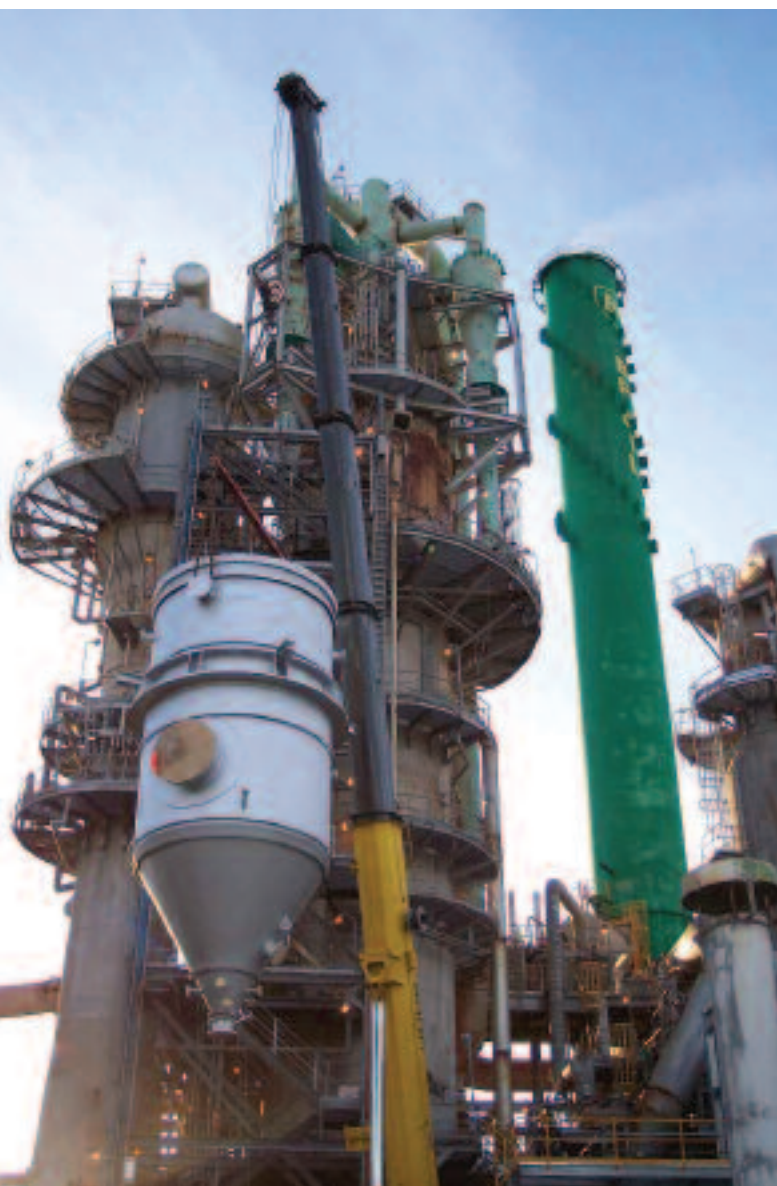
Fig 5: Filter vessel lifted into position

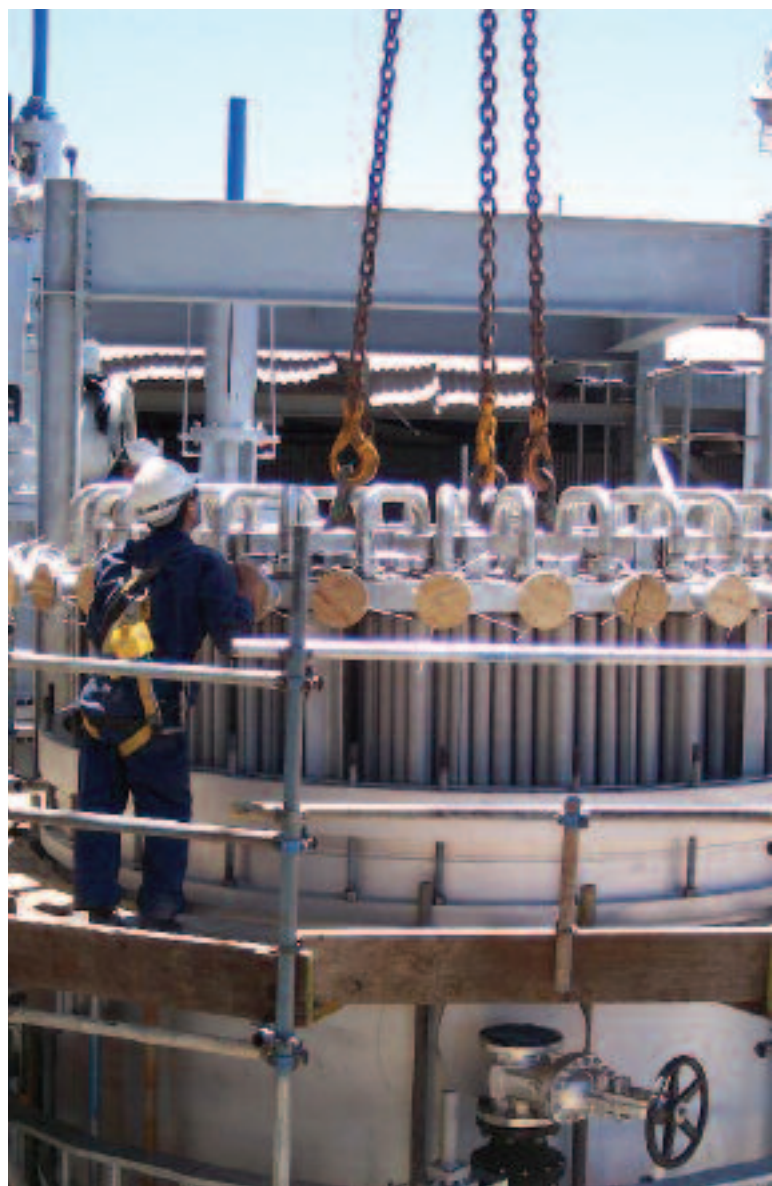
Fig 6: Filter tubesheet assembly installation

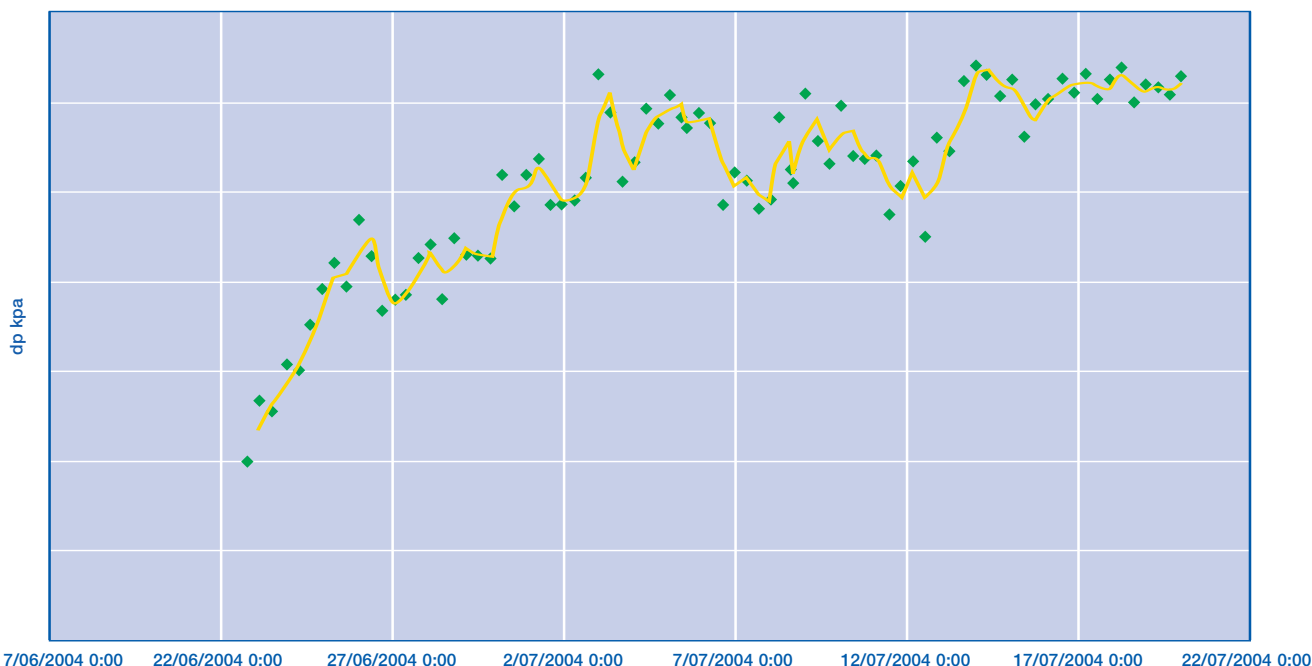
Recovery Filter Dp

Normalised to 100 m/hr fluxrate

DP corrected for plant air pressure & 1 kpa offset prior to 16/7/04

Fig 7: Filter Recovery dP (Normalised)

Since start up, the filter system has operated virtually without incident. The filter system achieved a steady state recovery pressure differential after approximately 100 blowback cycles which was in line with expectations. (Refer fig 7).

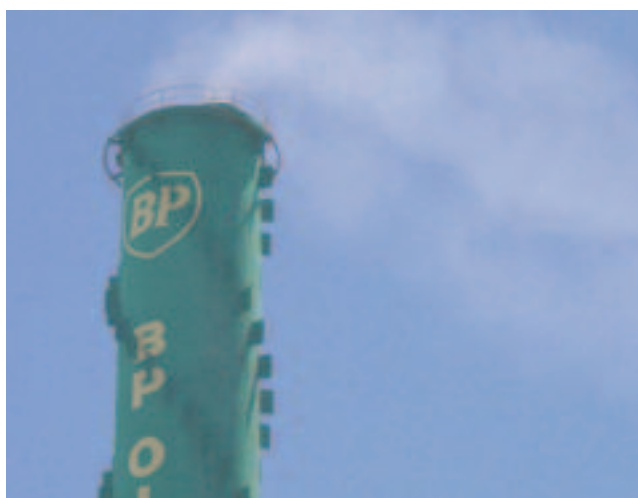
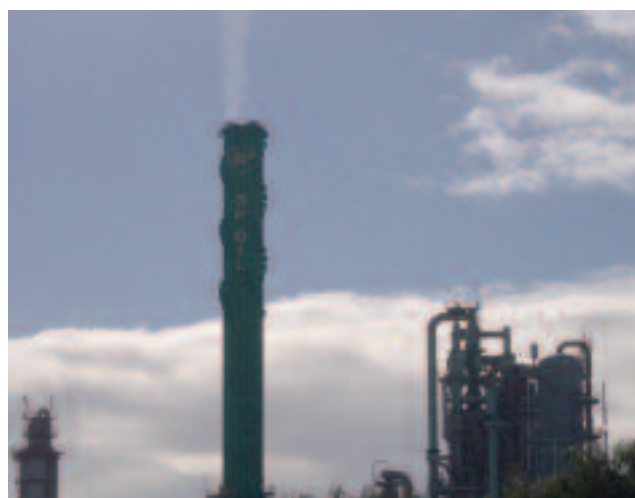
Fig 8: BP RCCU common stack before and after blowback filter start up. (Note: 2 plumes on left hand photo, and 1 plume on right hand side photo).

Following start up of the filter an opacity analyser was commissioned on the R2 stack. This analyser has read consistently less than 1%, with an average around 0.5%. This is believed to be equivalent to less than 5 mg/Nm³.

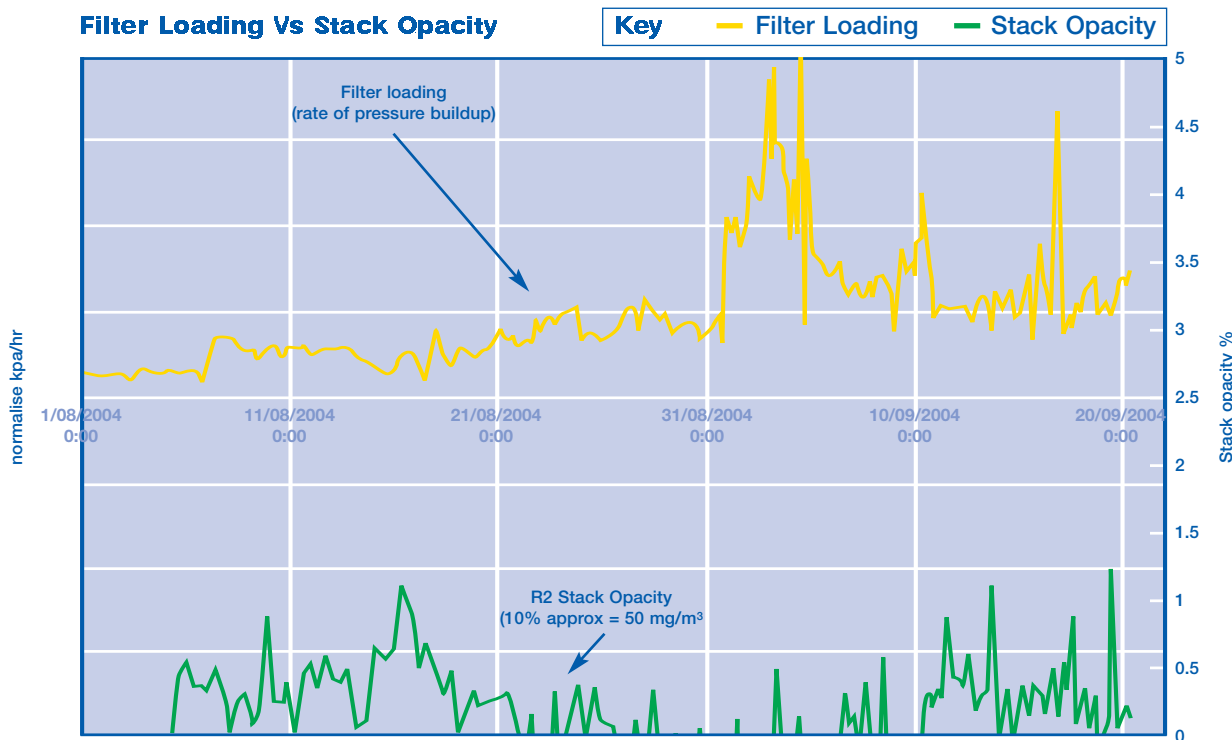
Fig 9: Increase in dust loading versus R2 stack opacity measurement

During late August/early September, BP Kwinana experienced a catalyst attrition problem which caused the solids loading to the blowback filter increase substantially from approximately 250 kg/day to 1000-2000 kg/day.

The emissions from the R2 regenerator remained constant throughout and allowed BP Kwinana to continue RCCU operation until the catalyst attrition issue was resolved without exceeding any licence limits.

Refer to Fig. 9 below to see the increase in loading without change in opacity at the stack.
